# **LAUNCH AND LANDING**

**STS-103**  
**FLIGHT READINESS REVIEW**

**November 19, 1999**

**Ground Operations**

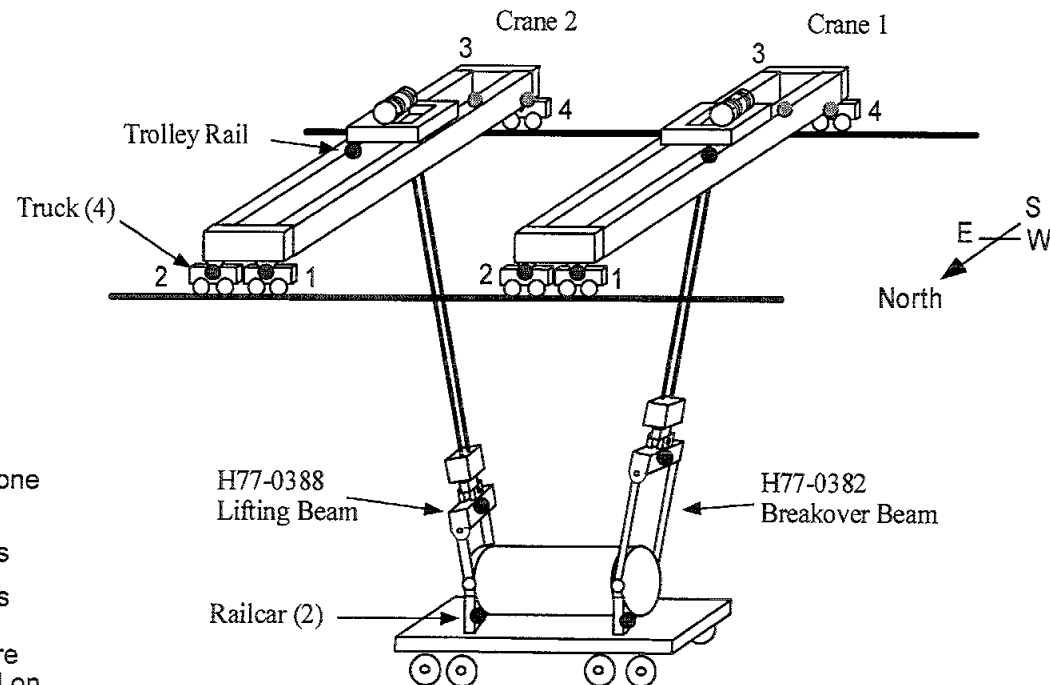
**UNEXPLAINED ANOMALY -  
RPSF NOISE INVESTIGATION  
(NORTH WEST WHEEL SLIDE ON CRANE 1)**

- 1-4 = Camera and microphone locations(both cranes)
- O = accelerometer locations
- Not shown: Accelerometers located on building "skin". Additional microphones were installed on the catwalk and on the RPSF floor.
